Date: April 26, 2018	Document Title: AP-66 and 66a – Colonial Motel Asbestos Closeout Report	Document #: 66 SSCR01
--------------------------------	---	---------------------------------

Asbestos abatement and RBM removal closeout report for the Colonial Manor Motel, AP-66 and 66a

AP-66 and AP-66a: Colonial Manor Motel

Asbestos Abatement

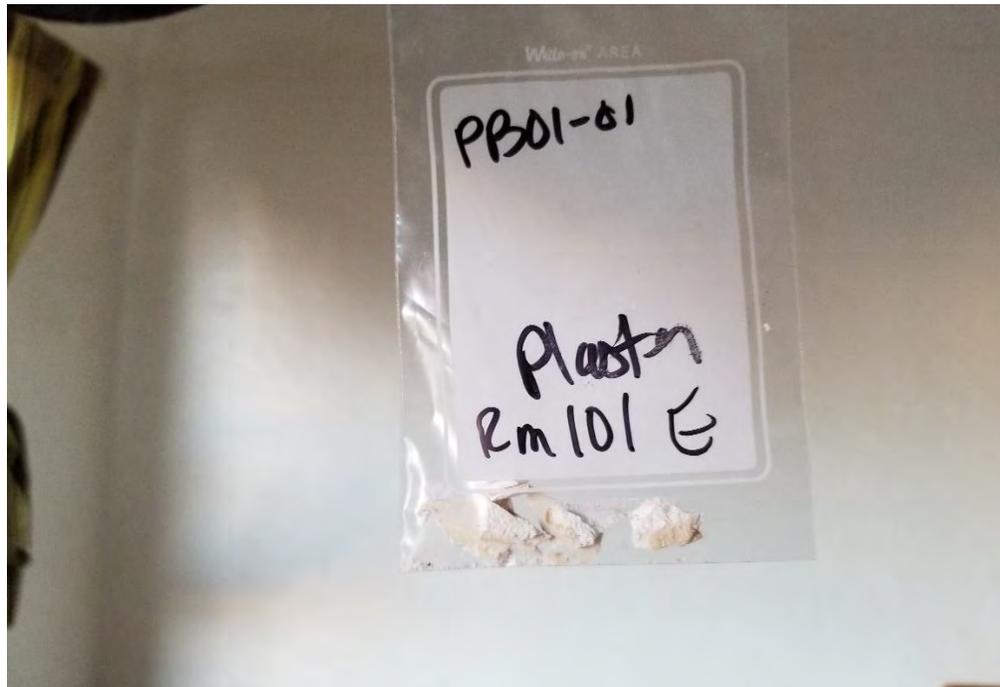
PB01 (LCP)
white paint on
plaster, Building
1, Building 2 and
Basements

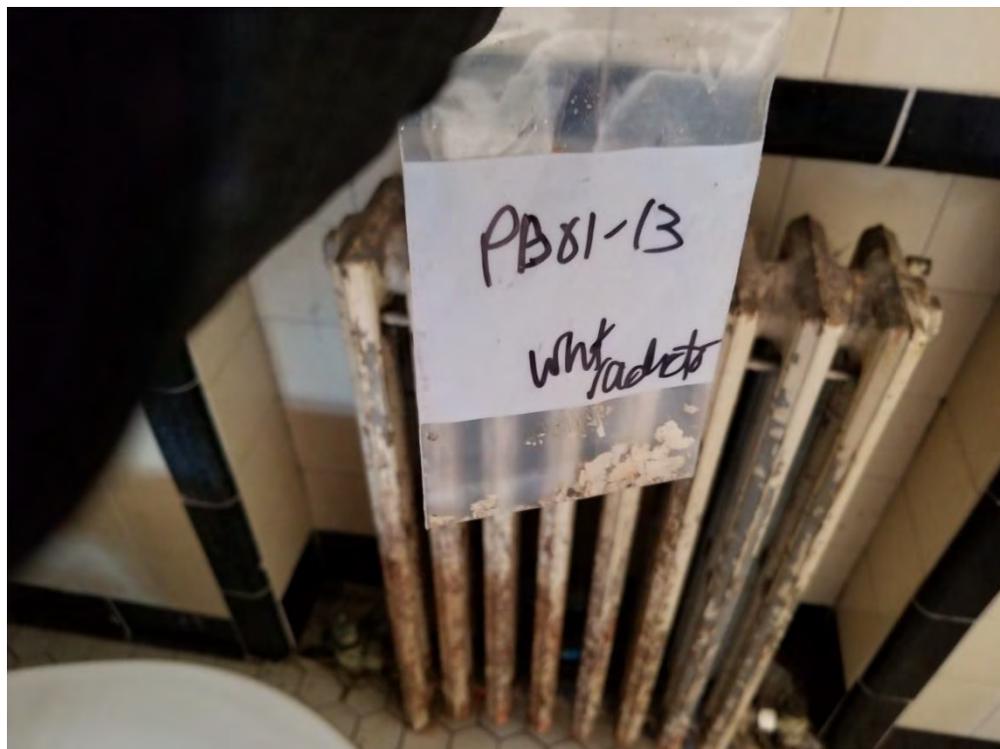
PB01 (LCP)
white paint on
radiator, Building
1 and Building 2

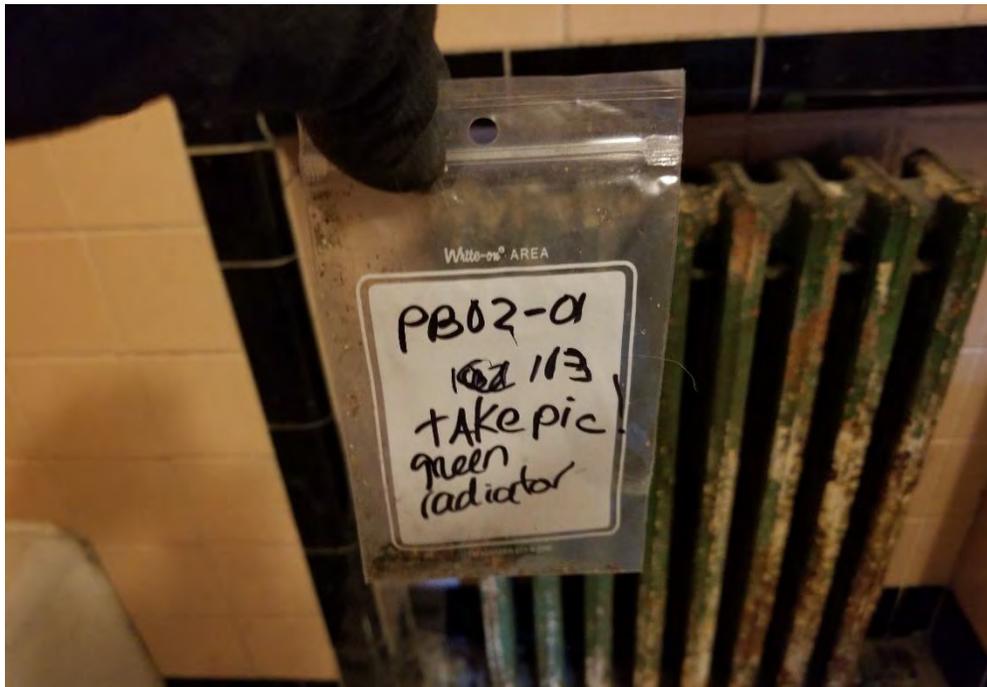
PB02 (LCP)
Green paint on
radiators
Building 1 and
Building 2

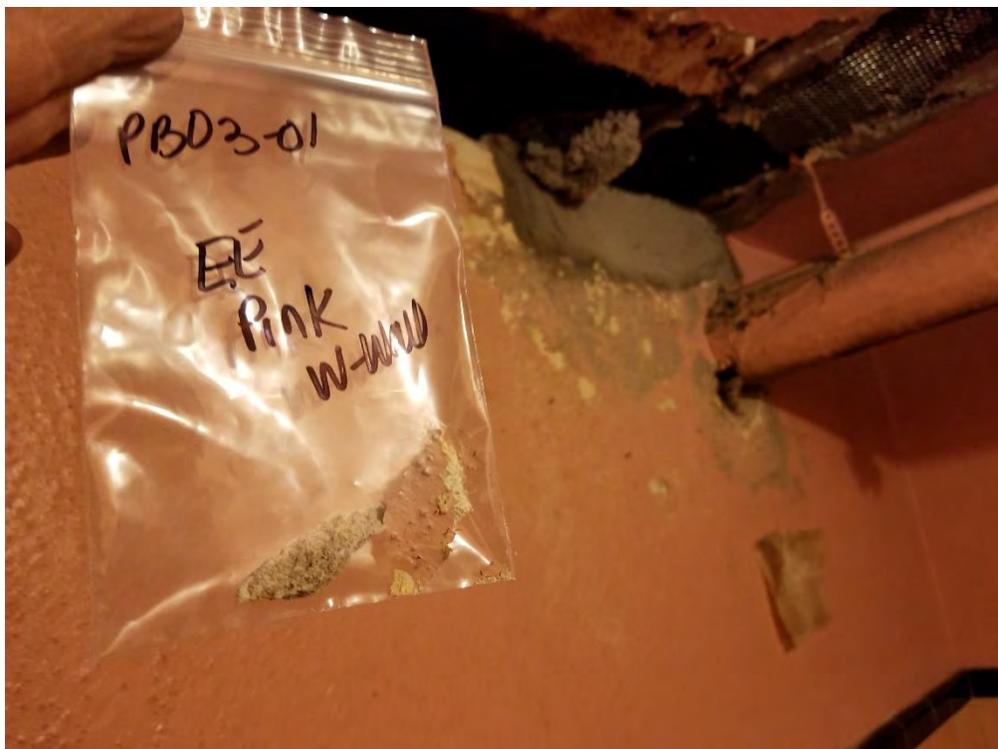
PB03 (LBP)
Pink plaster walls
and ceiling
Building 1,
basement
bathroom

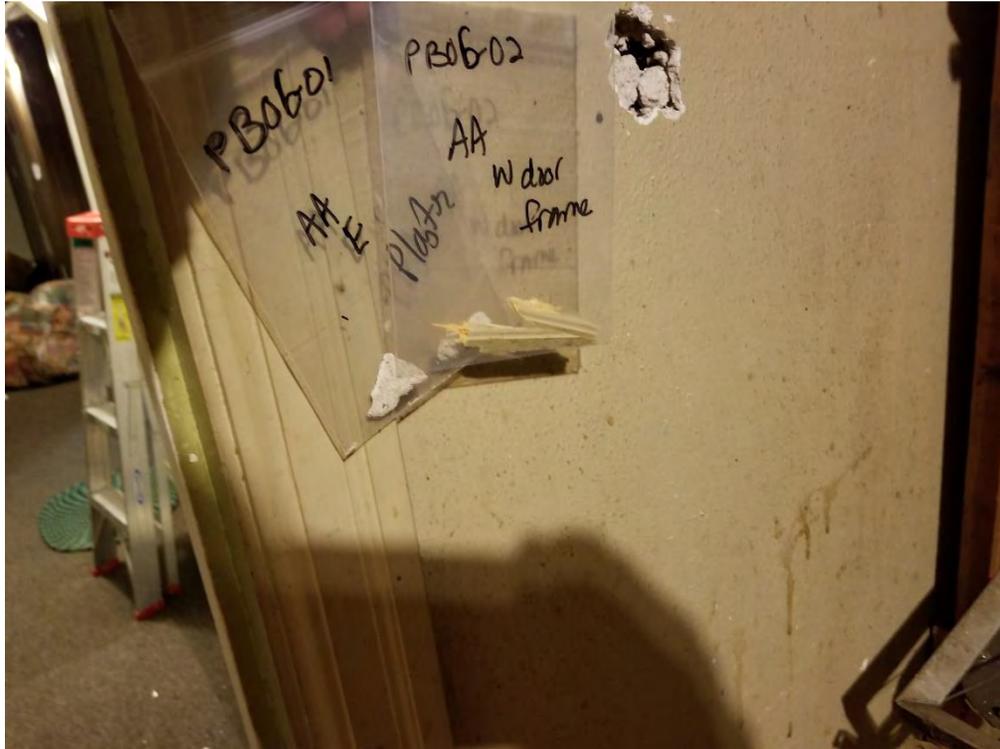
PB06 LCP tan paint on wood door frame and wall, Building 1, Office basement
